DECCA AUSTIN INSULATORS

A PRELIMINARY INVESTIGATION
INTO SOME FAILURE MODES
OF EGG TYPE INSULATORS

WESTERN ASSOCIATION OF BROADCASTERS

APRIL 29 - MAY 1, 1975

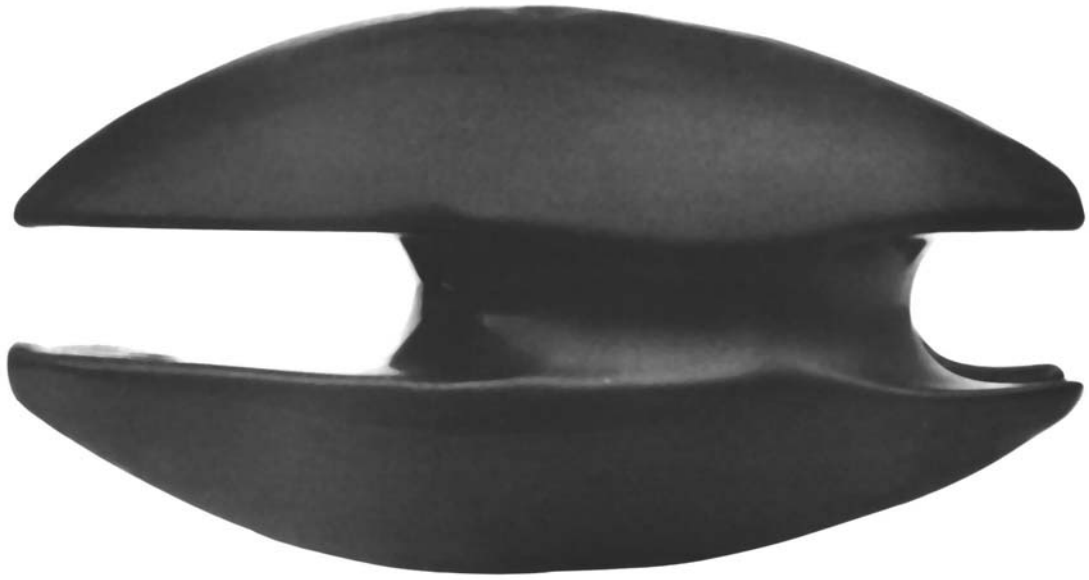
Figures 1 and 2 show differing styles of insulators in common use. Figure 1 is typical of British manufacture and Figure 2, U.S.A. and Canada. Figure 3 shows the electrical characteristics of several types of eggs. The first three on the list are the most interesting because they are virtually identical and commonly used in Canada. Decades ago, this type was made to a U.S. Navy Specification and we believe several companies still produce them. It is significant to note that Locke, one of the original manufacturers of this style insulator, specifically did not recommend its use as primary insulation at radio frequencies. The last two insulators mentioned in the Table are somewhat larger units than the three referred to above.

- 1 - British egg insulator
- 2 - Canadian egg insulator
- 3 - Comparison of egg insulators
- 4 - Summary of 60 Hz tests
- 5 - Arc erosion of a dielectric

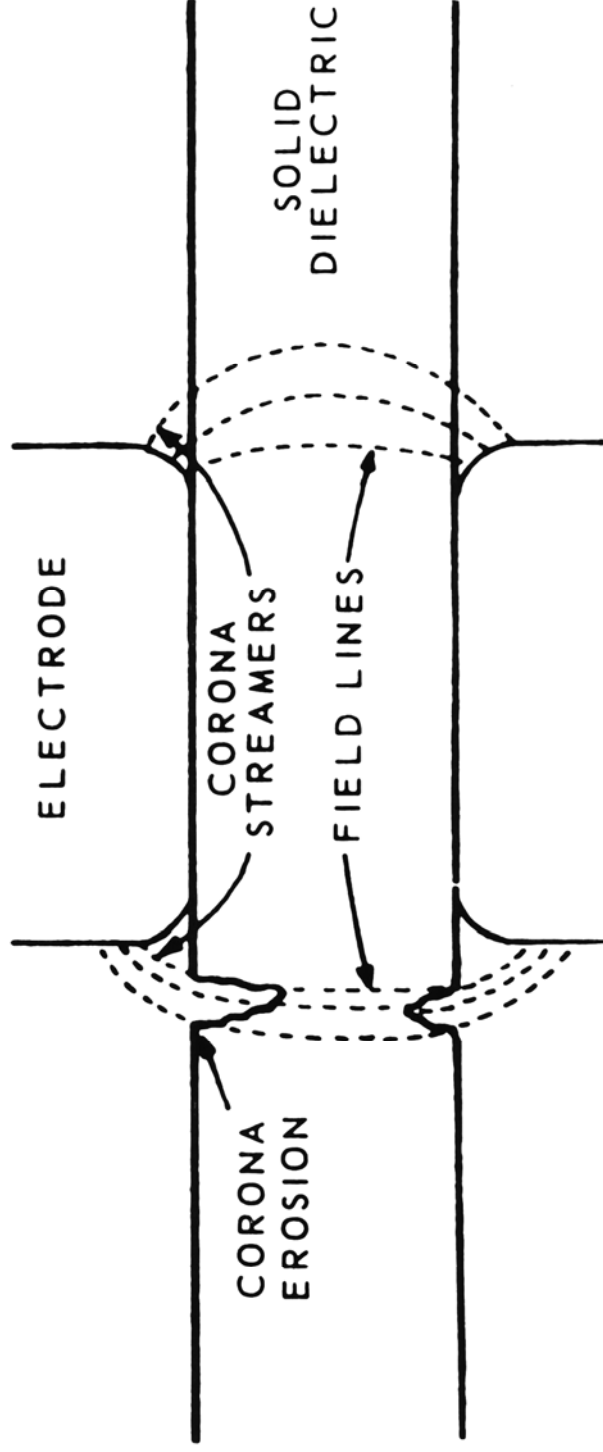
The interface between a conductor and a dielectric material, in this case the wire loop around the insulator, is a critical area. With the egg insulator under a compressive load between the loops, the wire is making intimate contact with some portion of the porcelain, but there is an adjoining area near the point of contact where there is a highly stressed region or air. Figure 5 illustrates this. As soon as this air is over-stressed, ionization occurs, a small arc develops, and highly destructive ozone and heat are produced. The insulator surface, at the point where the arc occurs, becomes very hot, and if the arc is allowed to continue, the glaze may melt and the insulator surface erode. A more likely occurrence is for the ceramic to crack quickly due to mechanical stress resulting from the heat of the arc. The arc will then work its way through the crack since air will enter and readily break down. The process continues until the insulator falls apart.

**CORONA DISCHARGE PRODUCES HIGH FIELD STRESS IN
SOLID DIELECTRIC AND EVENTUALLY CAUSES FAILURE.**

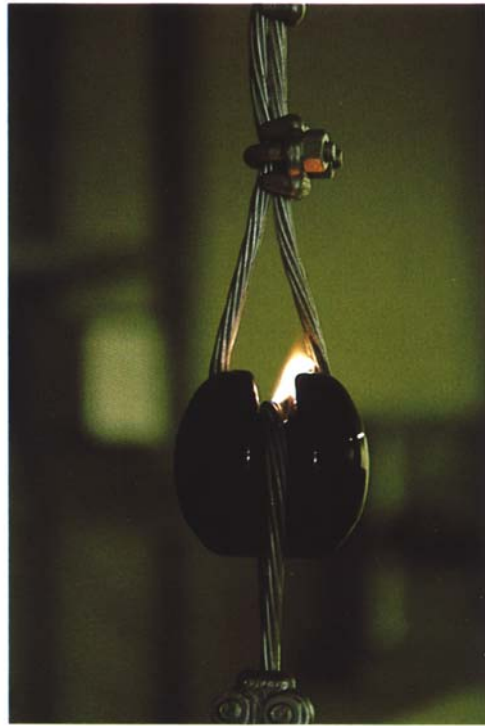
2

We first investigated the behaviour of one insulator under dry conditions. A few patches of blue discharge appeared at 8.5 KV as the voltage was being raised. This visible discharge was similar to that which will be seen on Slide 5.

As the voltage was raised further, the blue discharge became intense at 10 KV and after a few seconds an arc occurred which was initially over the surface of the porcelain at the top and between the wire loops. This is shown in Slide 2.

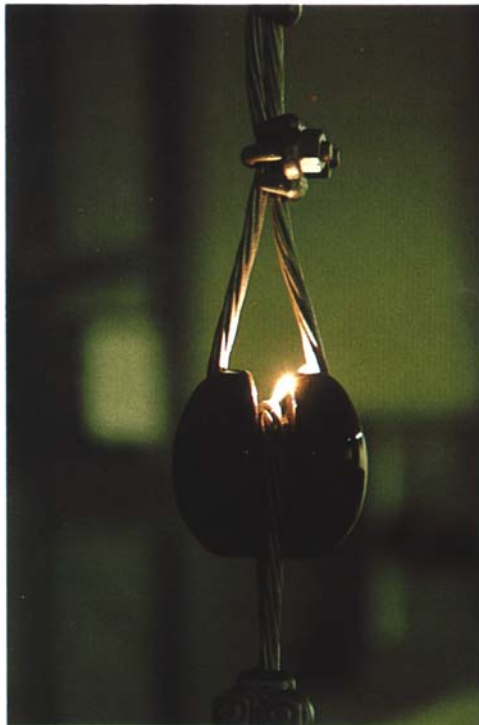
After a minute or so a crack developed in the porcelain and the

appearance of the arc changed from that shown in Slide 2. It will be noted in Slide 3 that the arc is not continuous over the top of the porcelain but is, in fact, passing through a crack.

Though voltages of 8 - 10 KV were involved in the initiation of the arc, once the arc was formed the voltage across the insulator dropped to about 3 KV and required a further reduction to extinguish it.

After a few minutes of operation with the arc present, the glaze melted under the arc and when the power was shut off the ceramic was white hot in the area where the arc occurred.

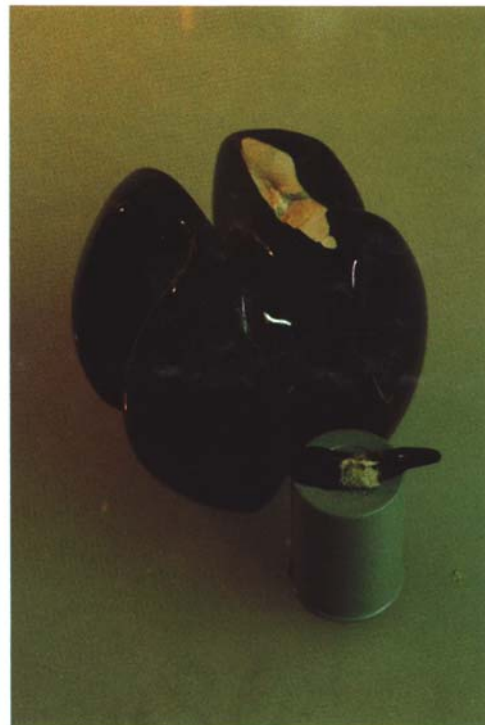
4

This shows the insulator and the broken chip.

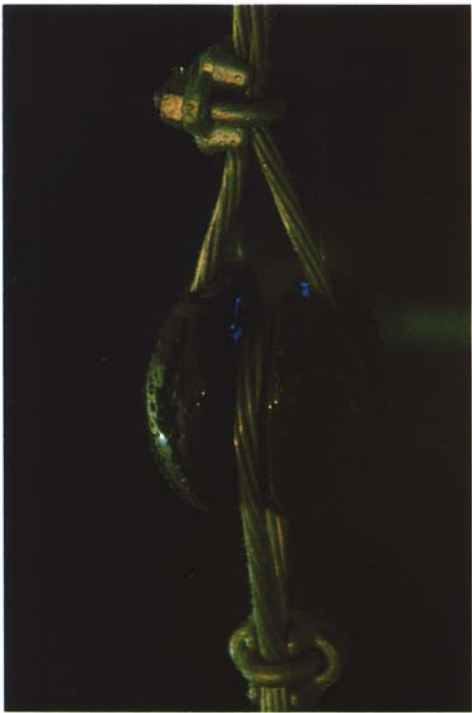
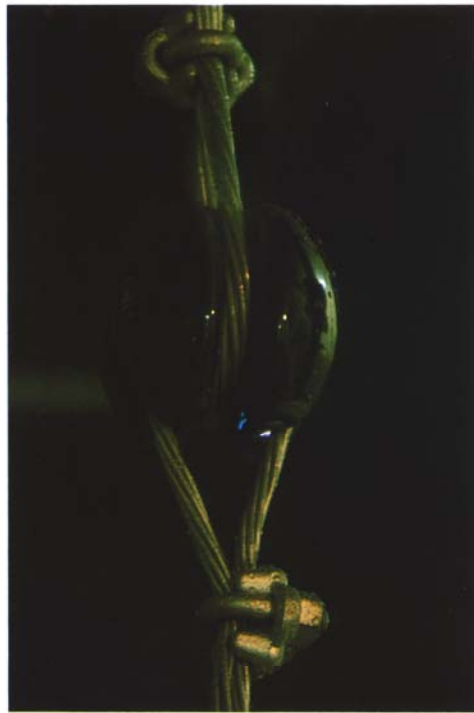
Slides 5 and 6.

With the insulator wet a visible discharge started at 7 KV. The discharge was at the bottom of the insulator, probably due to the concentration of water at that point. (Slide 5 has been inadvertently printed upside down).

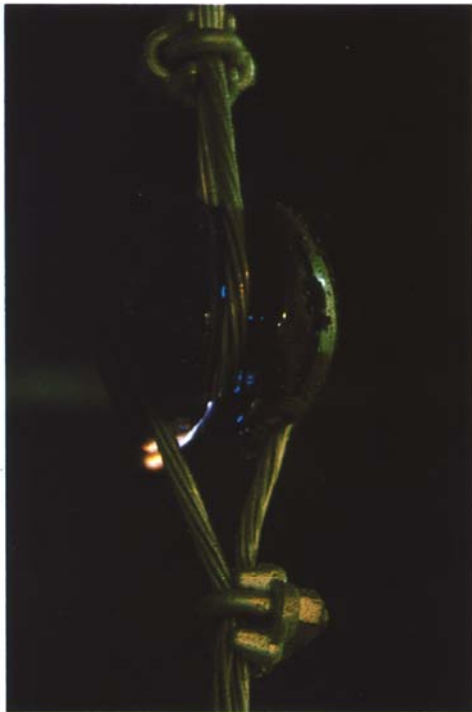
7

This slide shows the effect of further wetting and an increase in voltage to 8 KV. There is more evidence of visible discharge and an arc has formed.
